Kennedy Derailment

Commission Meeting

February 27, 2008

Kennedy Train Derailment Incident Summary

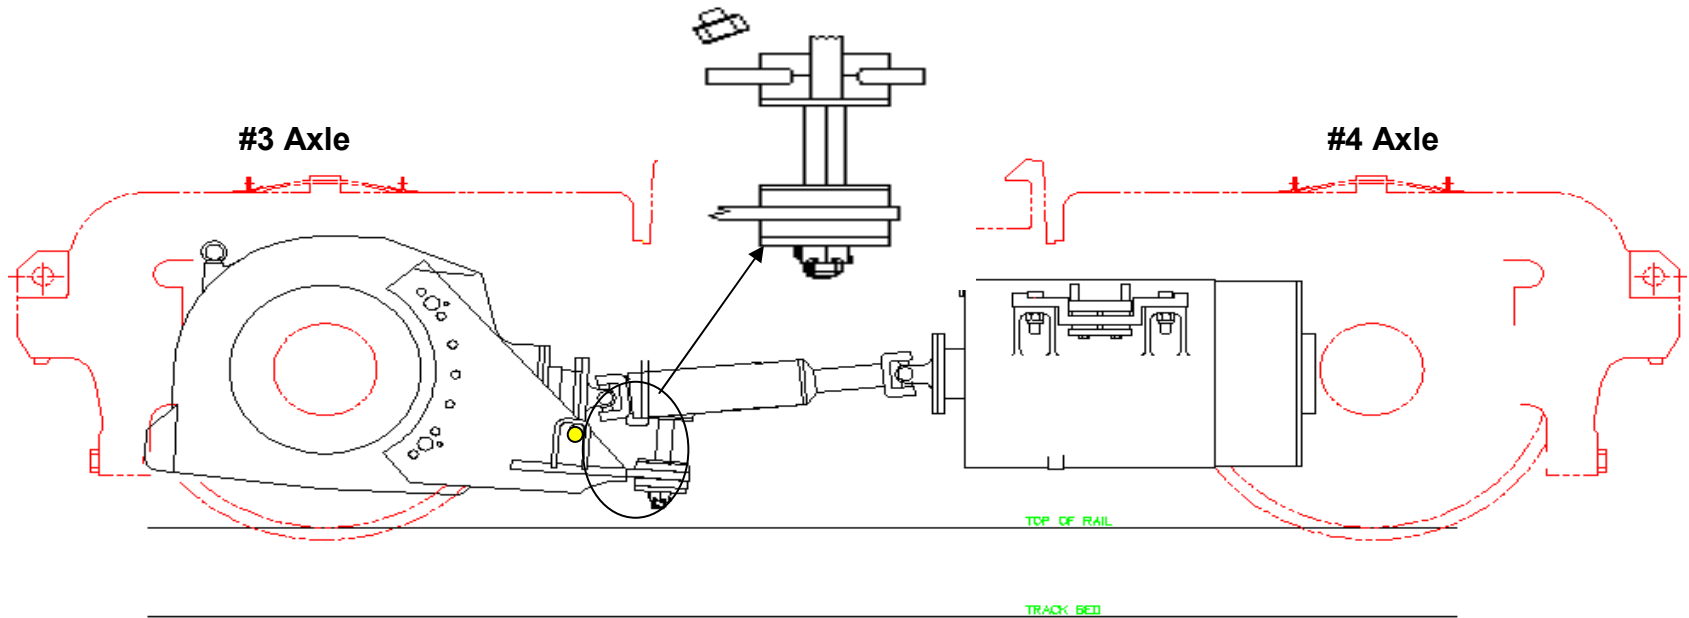
Failure of Torque Arm Link Location Undetermined

- **Upper threaded section failed just below nut.**
- **Torque arm dropped onto safety pin.**

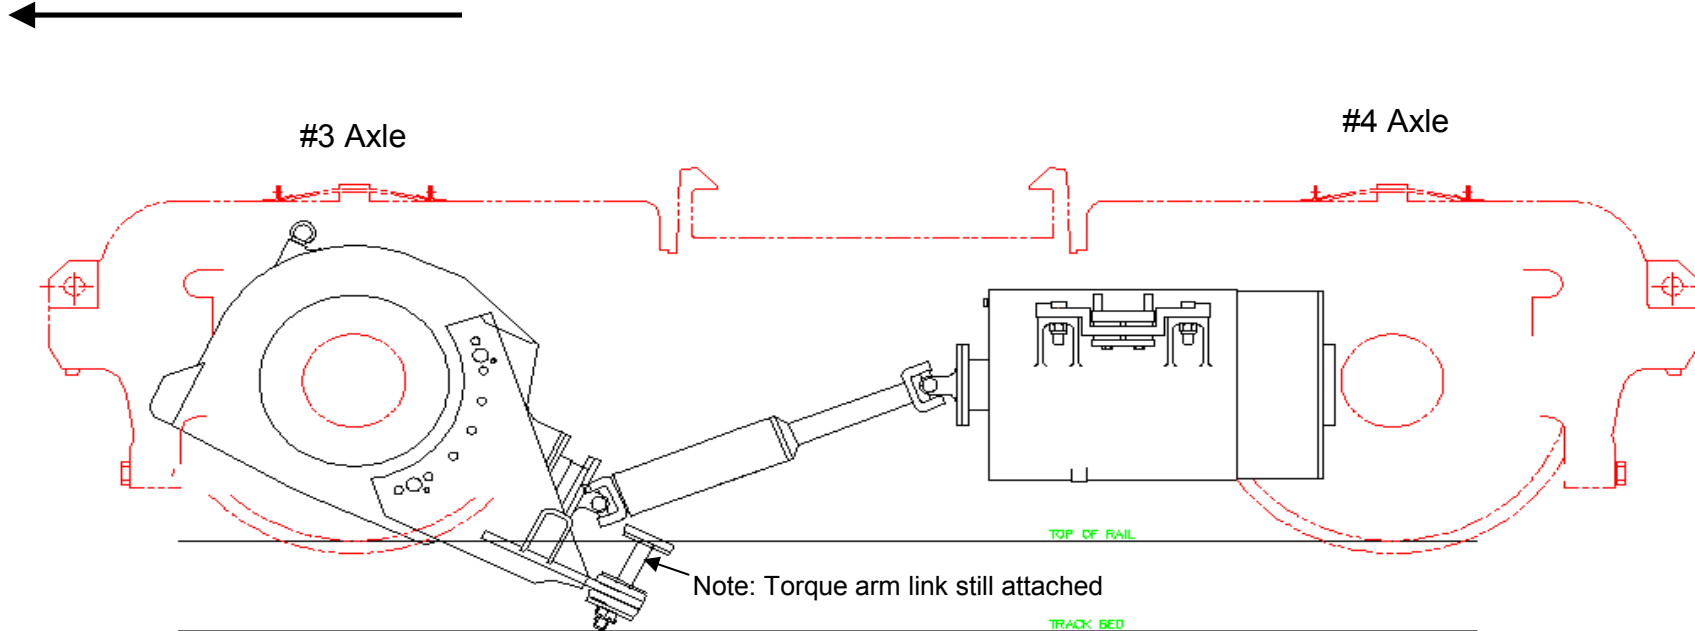
Loss of Torque Arm Safety Pin Sherbourne – Castle Frank Vicinity

- **Safety pin falls out, torque arm drops on to track bed.**
- **Immediate catastrophic driveshaft failure occurs.**
- **Contact at track bed causes forward bending of link.**
- **Upward travel of torque arm cause link contact truck frame.**
- **Link falls off (Donlands), then torque arm (Victoria Park).**

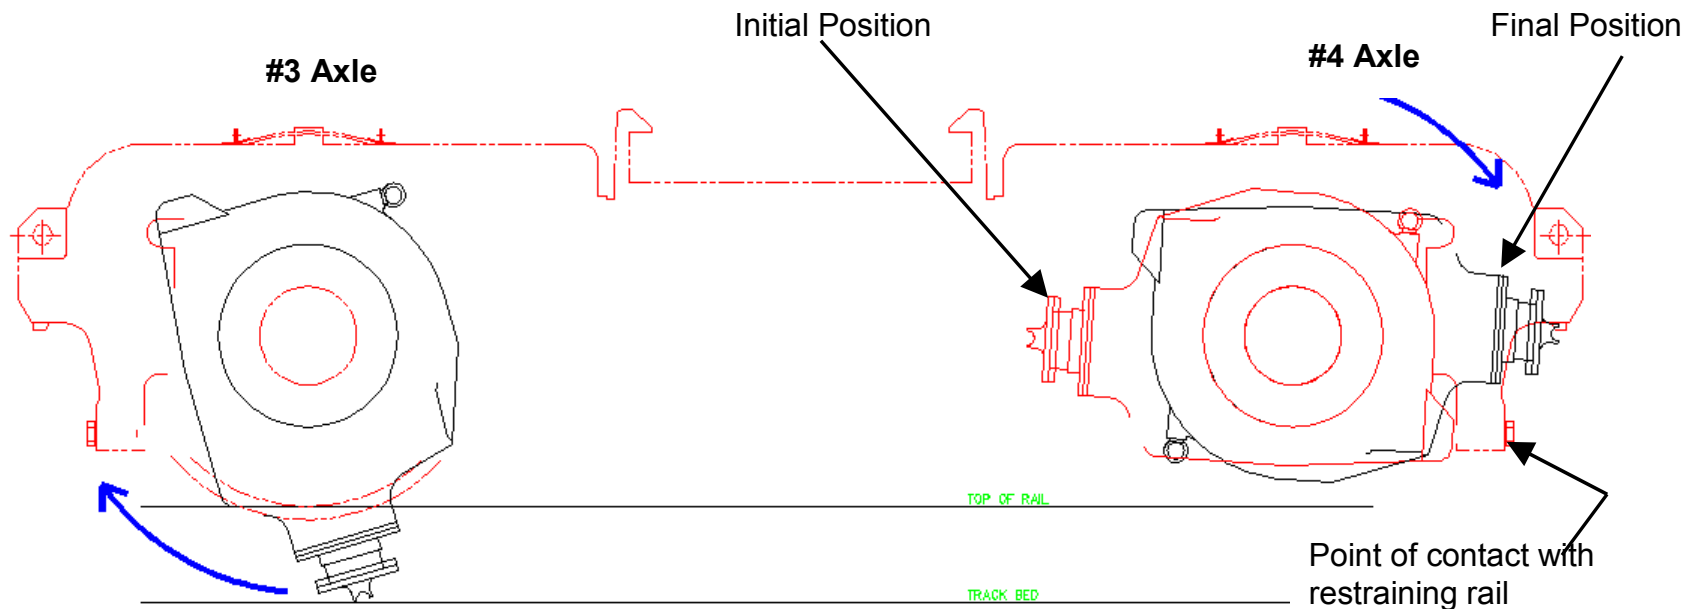
Derailment Kennedy Crossover

- At Kennedy, train changes direction to Westbound, car 5857 was the trailing car.
- Gearbox #3 rotated down and struck track bed, vaulting & derailing truck.
- Axles riding on track bed and 12" to the South of the rails
- Gearbox #4 struck retaining rail.
- Impact caused gearbox #4 to rotate upwards ending 180° out of position.
- Center pin sheared, allowing car body to move forward approx. 2' on the #2 truck.
- Extensive damage to track bed, switch and signal equipment.

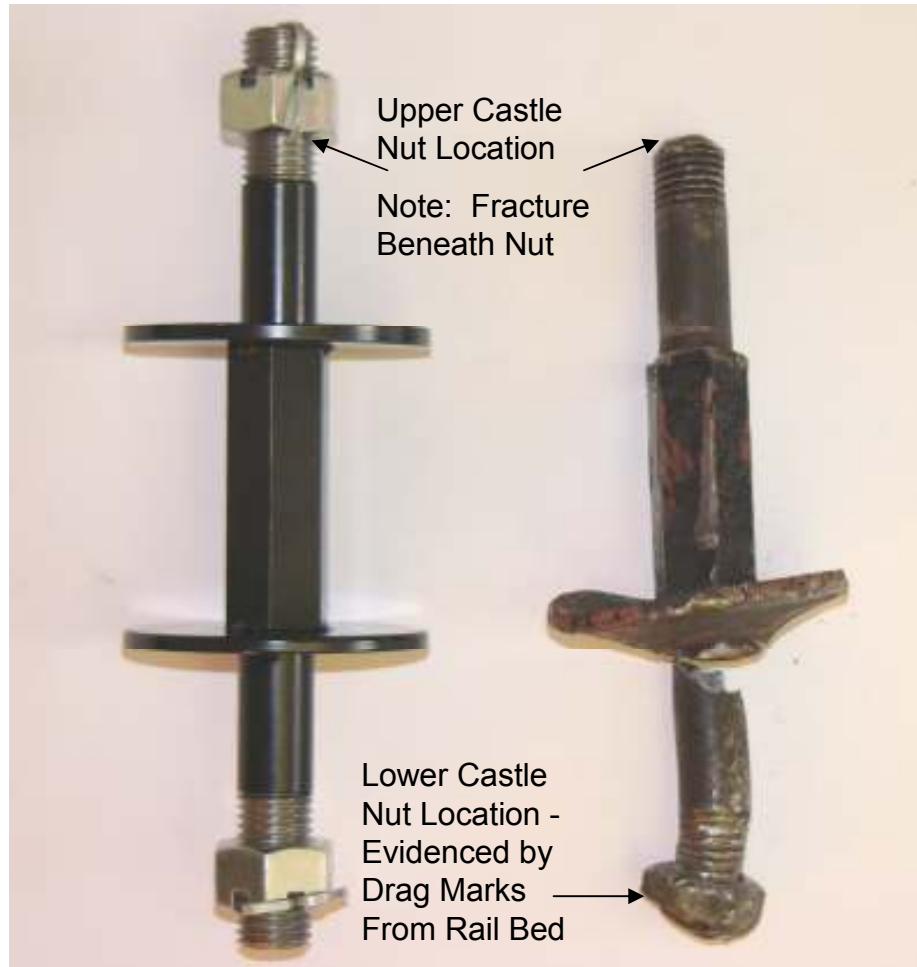
Fatigue Failure of Torque Arm Link

Primary Failure Mode

Torque Arm Link Redesign

- Increase assembly strength.
- Eliminate possible wear from metal washer to central bolt.

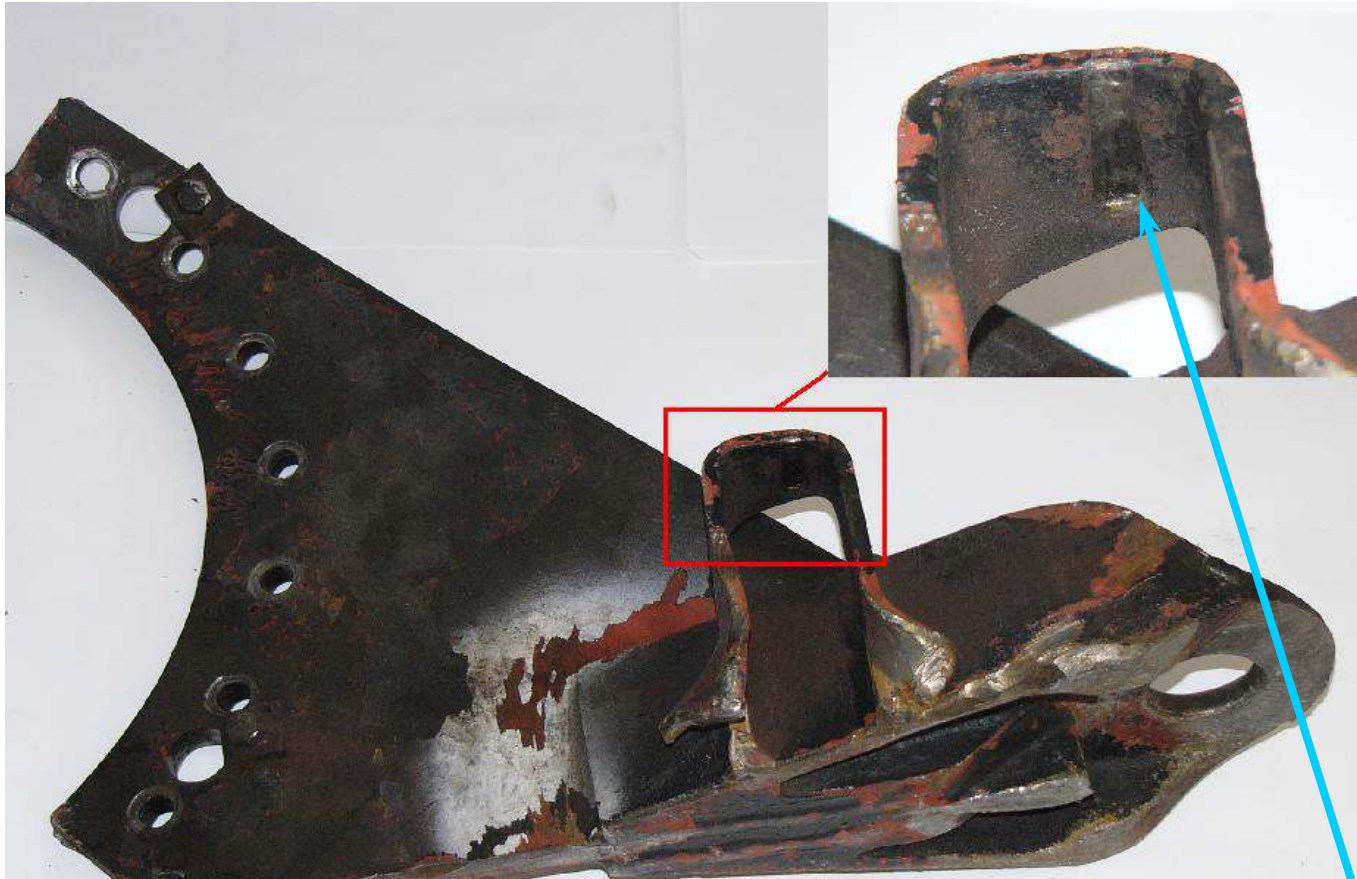
Safety Pin - Torque Arm

- Contact mark inside “U” bracket significant evidence of vertical impact of torque arm on safety pin.

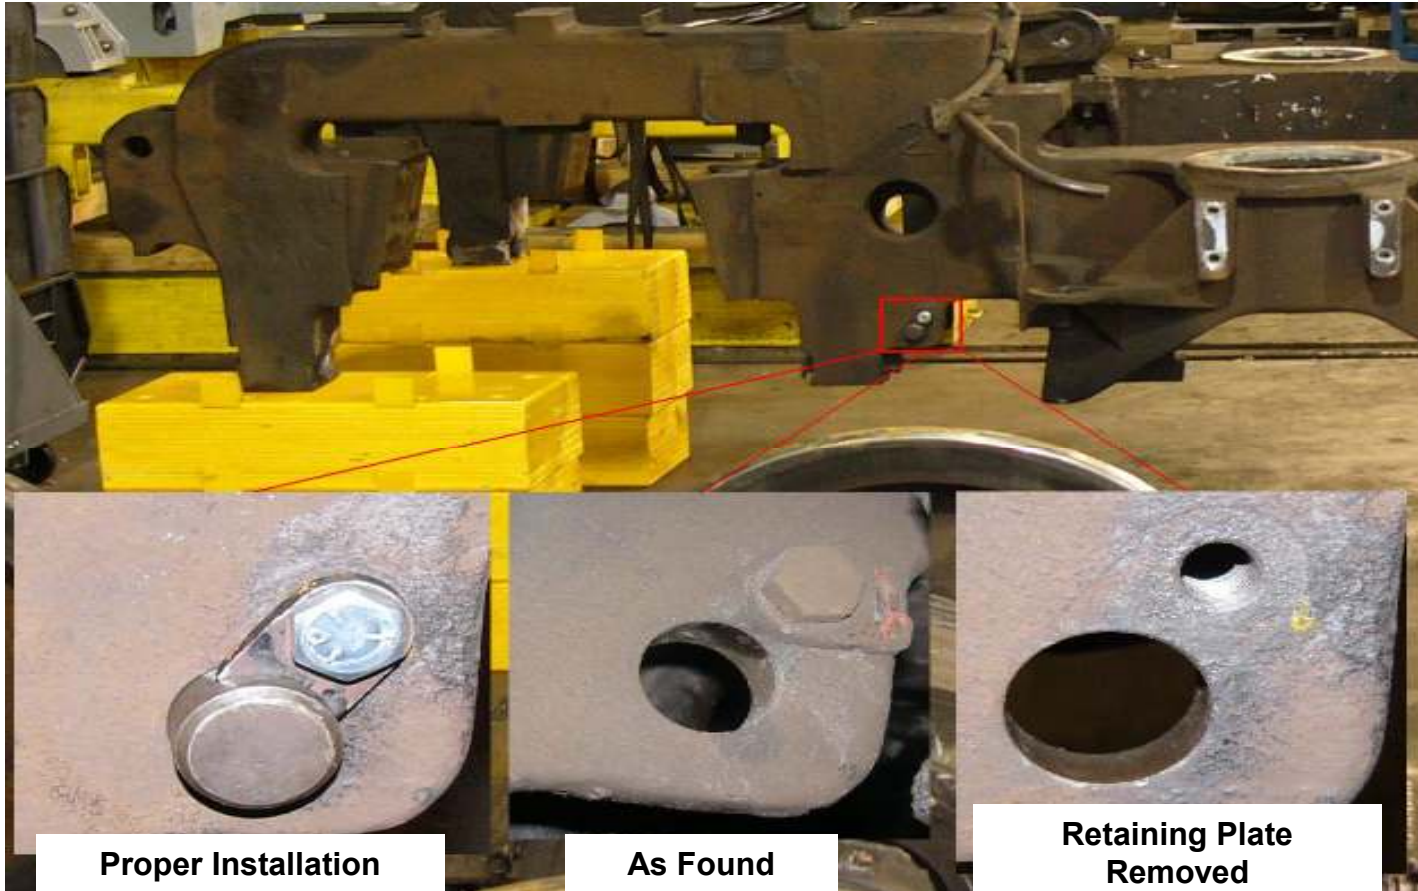
Safety Pin – Safety Retaining Plate

Secondary Failure Mode

Redesigned Safety Retaining Plate
