Kennedy Derailment

Commission Meeting

February 27, 2008

Kennedy Train Derailment Incident Summary

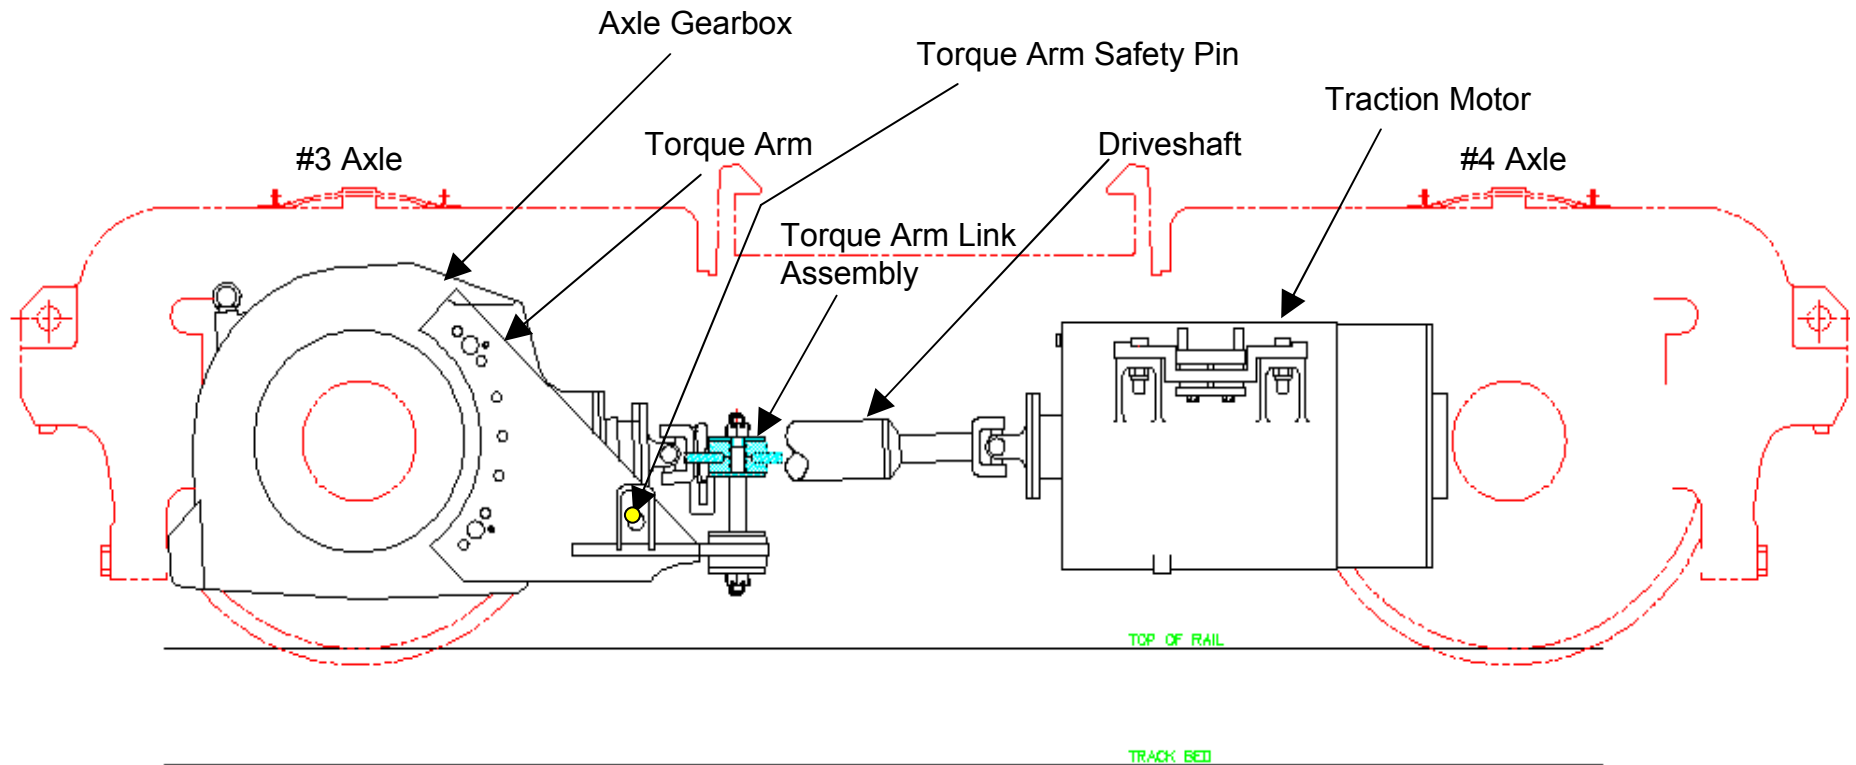
Driveline Configuration

- Torque arm link transfers force from torque arm to truck frame (blue).
- Torque arm safety pin (yellow) is secondary restraint limiting torque arm travel if torque arm link fails.

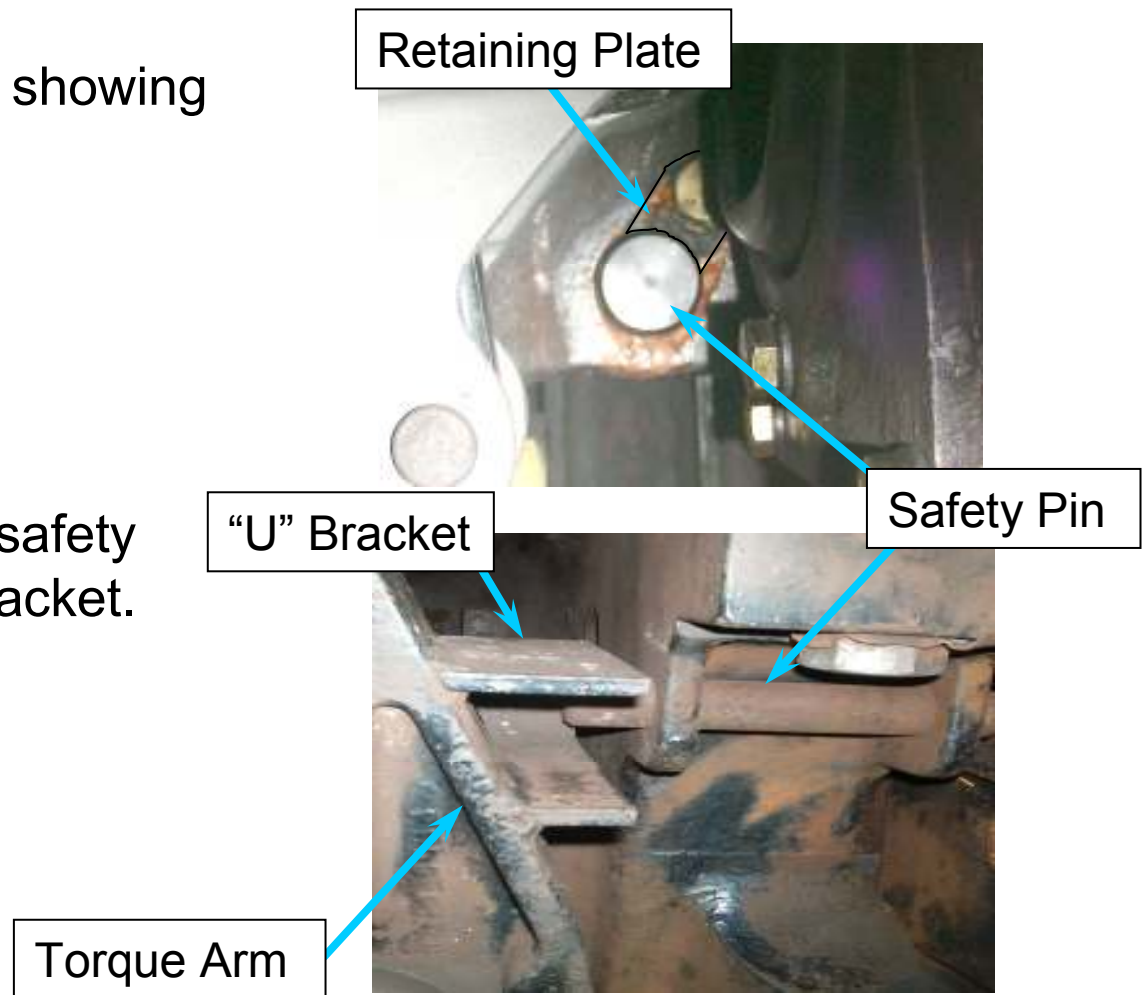
H6 Safety Pin Secondary Restraint

- End view of safety pin showing retaining plate
- Bottom view showing safety pin engaged in “U” bracket.

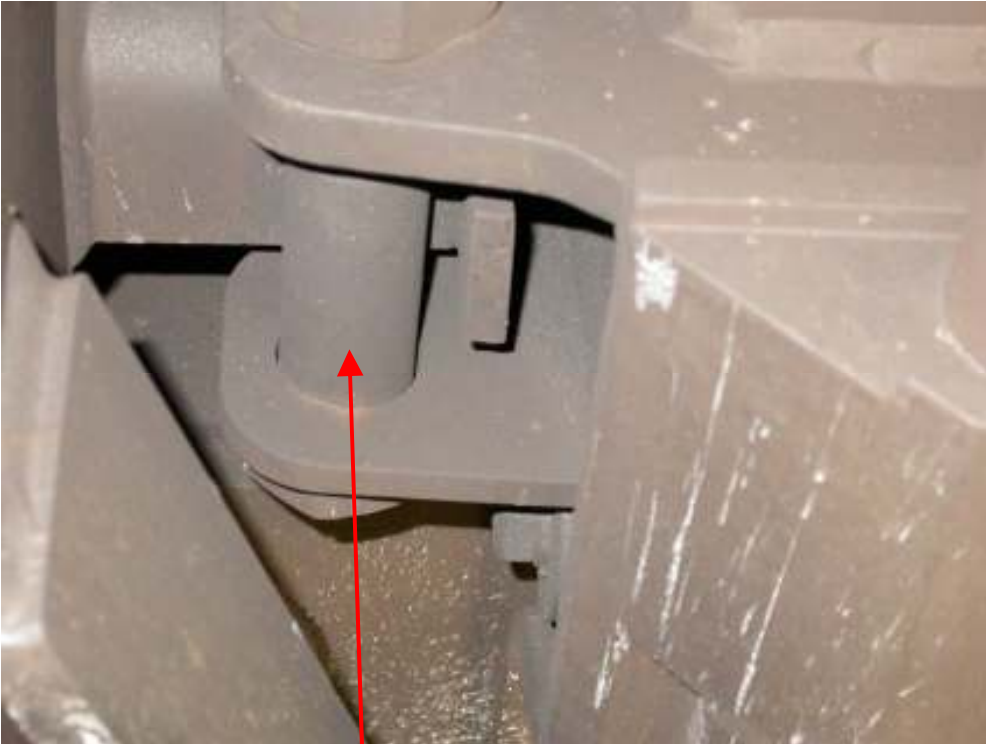
T1 Torque Arm Secondary Safety Support

- T1 torque arm supported by bolt not pin
- Bolt held at both ends by truck frame not cantilevered like H6

- T1 Torque arm safety bolt
